TEATRO NACIONAL DE SÃO JOÃO

SÃO JOÃO NATIONAL THEATRE

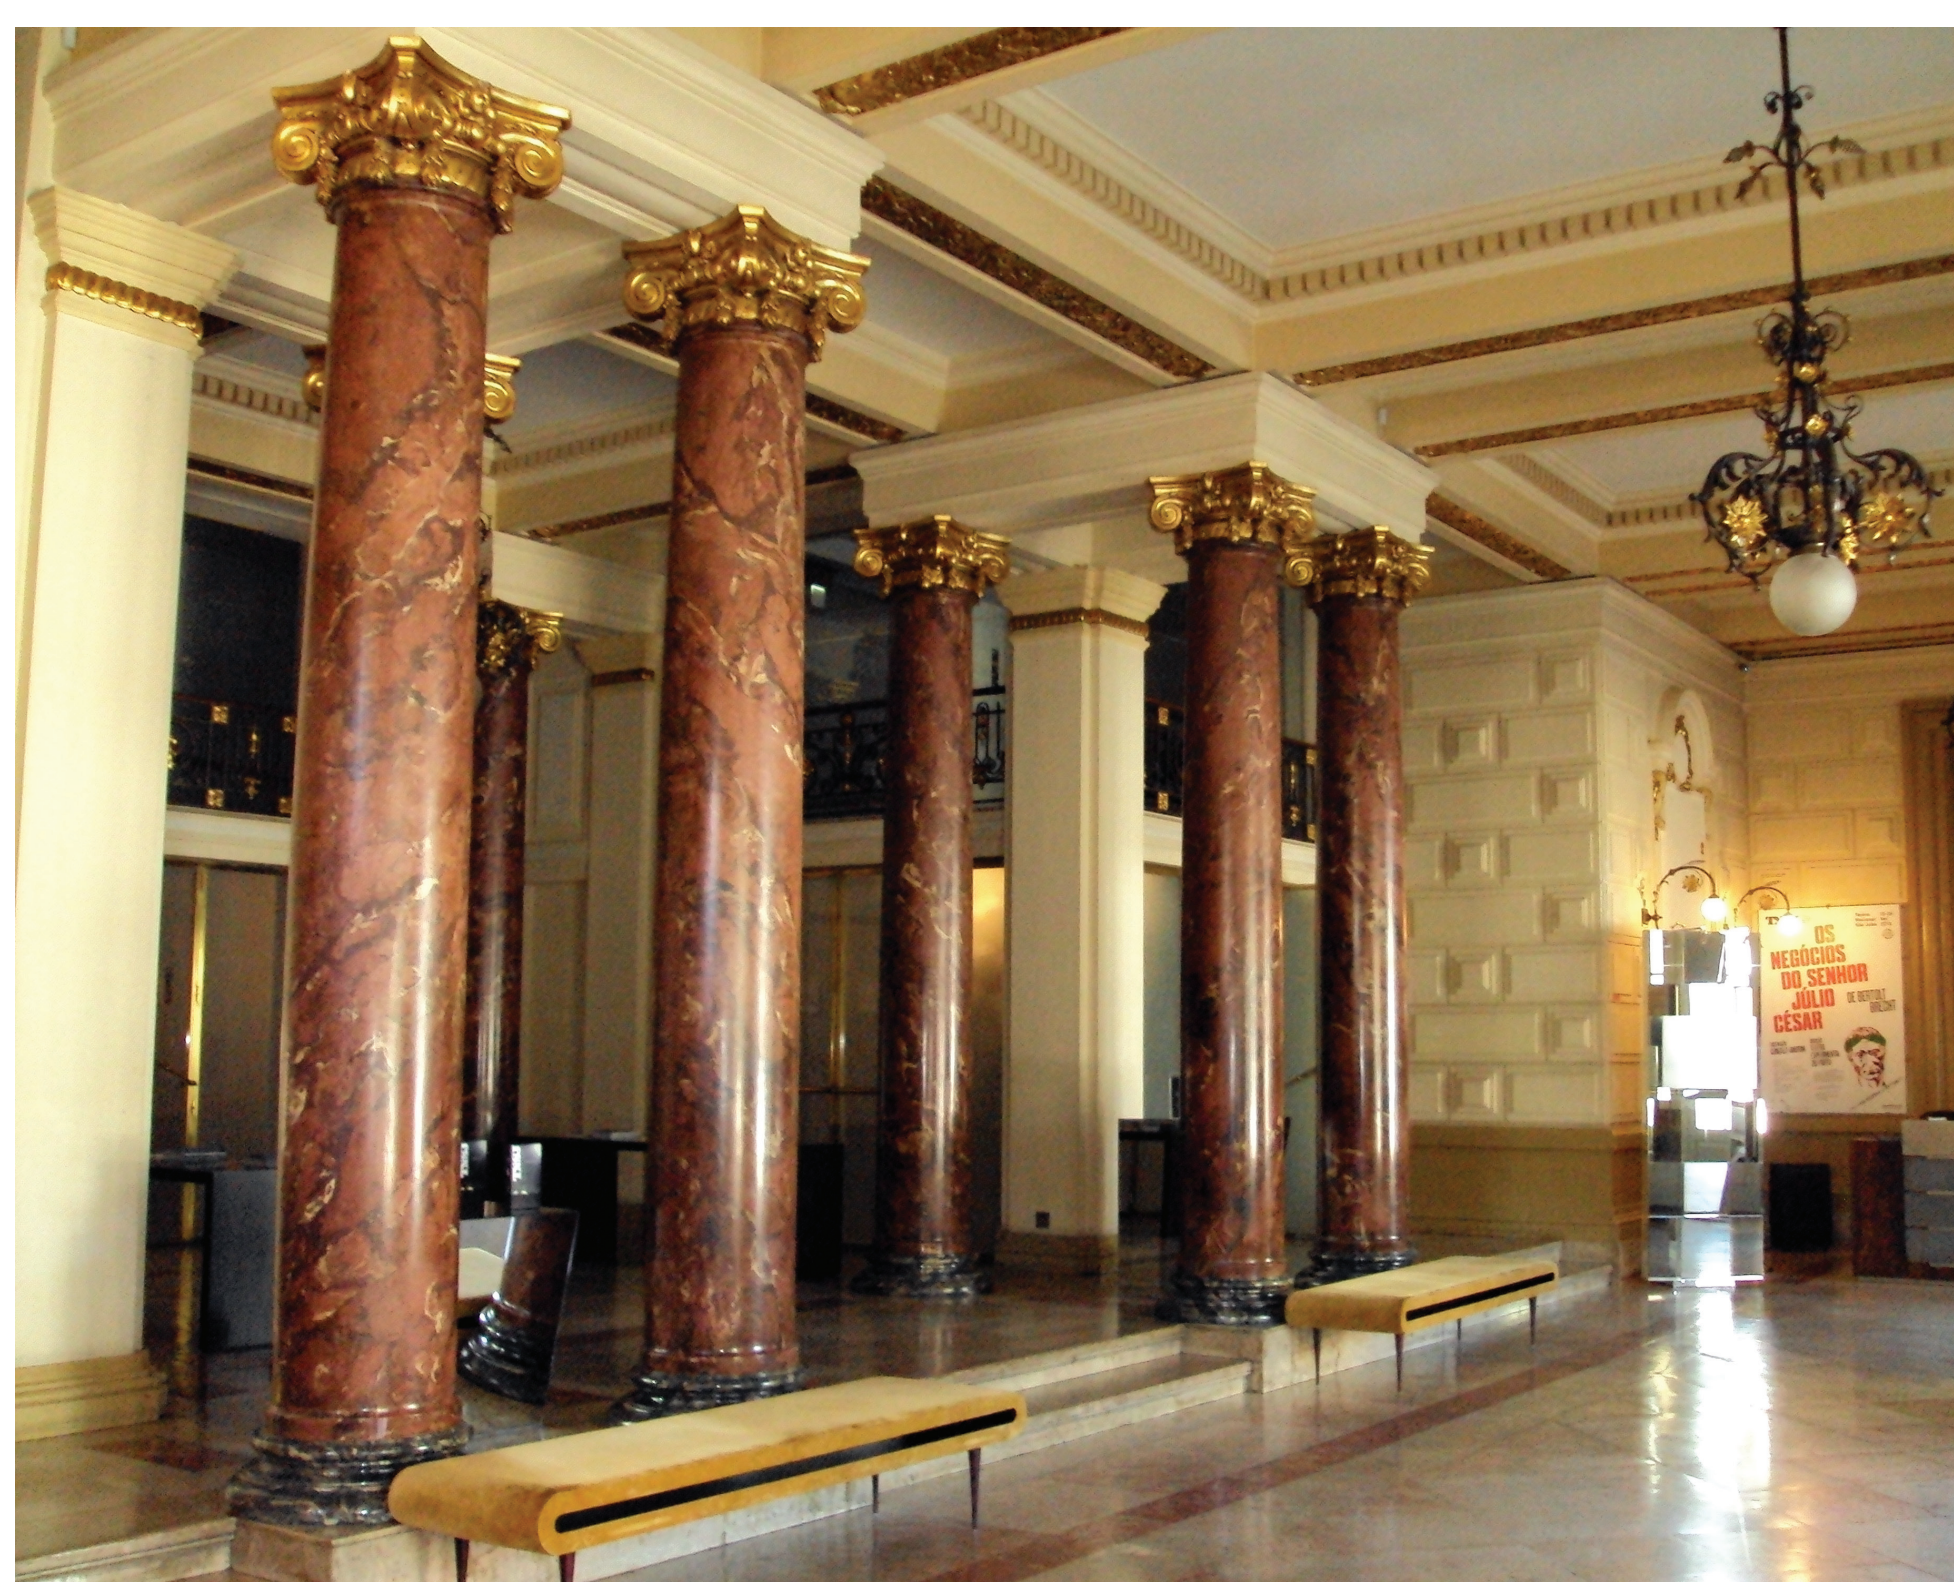
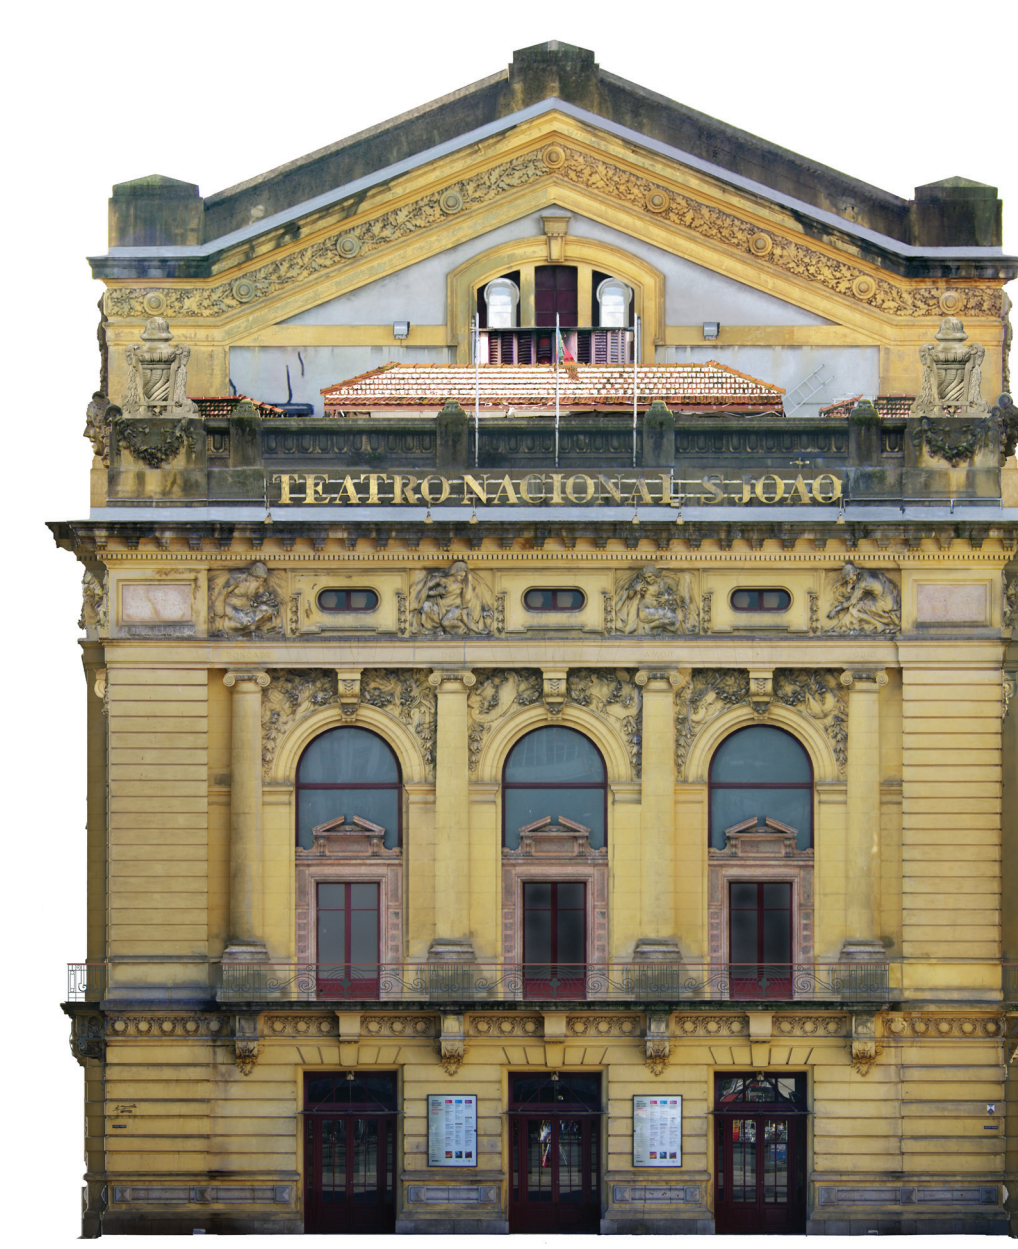
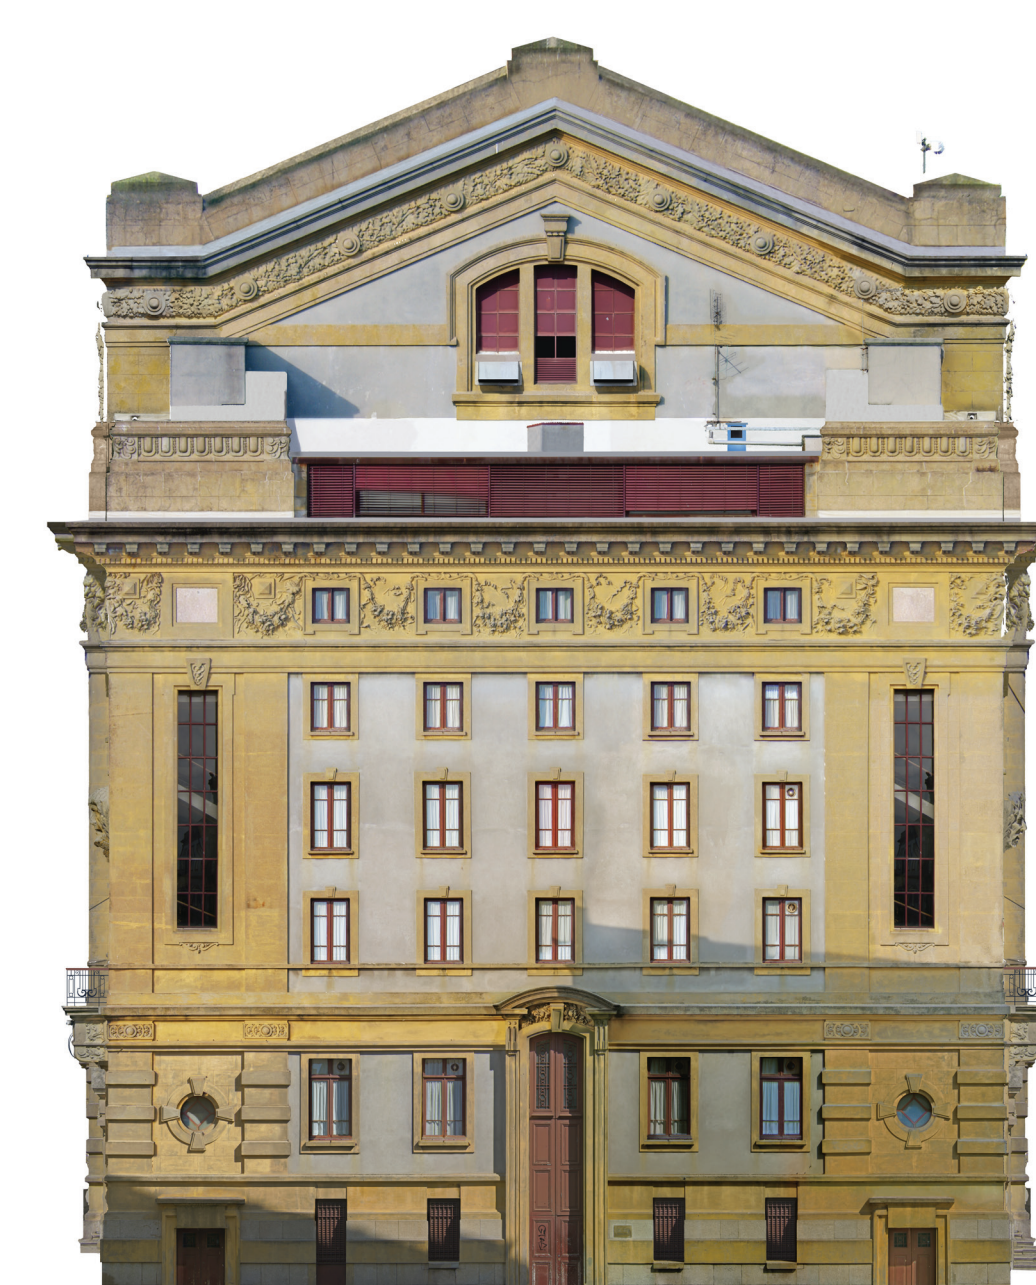
The façades of the Teatro Nacional S. João feature some anomalies that motivated the elaboration of detailed studies of mapping and diagnosis of pathologies, in order to define the required rehabilitation strategy.

The trials conducted in the armed mortar façades revealed that these are composed of cement-based ligand and sands of siliceous nature. The reinforcement coatings are very variable, not noting, in general, relevant contamination by chlorides.

Visual inspection performed has shown us the existence of various anomalies, the most relevant being related to detachment and falling pieces of sculptures and reliefs of the façades. These anomalies are due to reinforcement corrosion that arise associated with expansion, causing cracking and delamination of mortars, being compounded by insufficient armor rods covering sculptures, excessive porosity of mortar and lack of preservation of superficial protection coating, associated to exposure to rains, winds, atmospheric pollution and temperature changes.

The sub-vertical façade cracking appears to be due to differential settlements and also possible to temperature variations associated with the large dimensions of the building. The remaining façade anomalies, notably biological colonization, guano accumulation, paint coatings degradation, metallic guards corrosion and anchorages for masonry elements corrosion are mainly due to the lack of maintenance/conservation.
