PONTE DE PONTE DA BARCA

PONTE DA BARCA BRIDGE

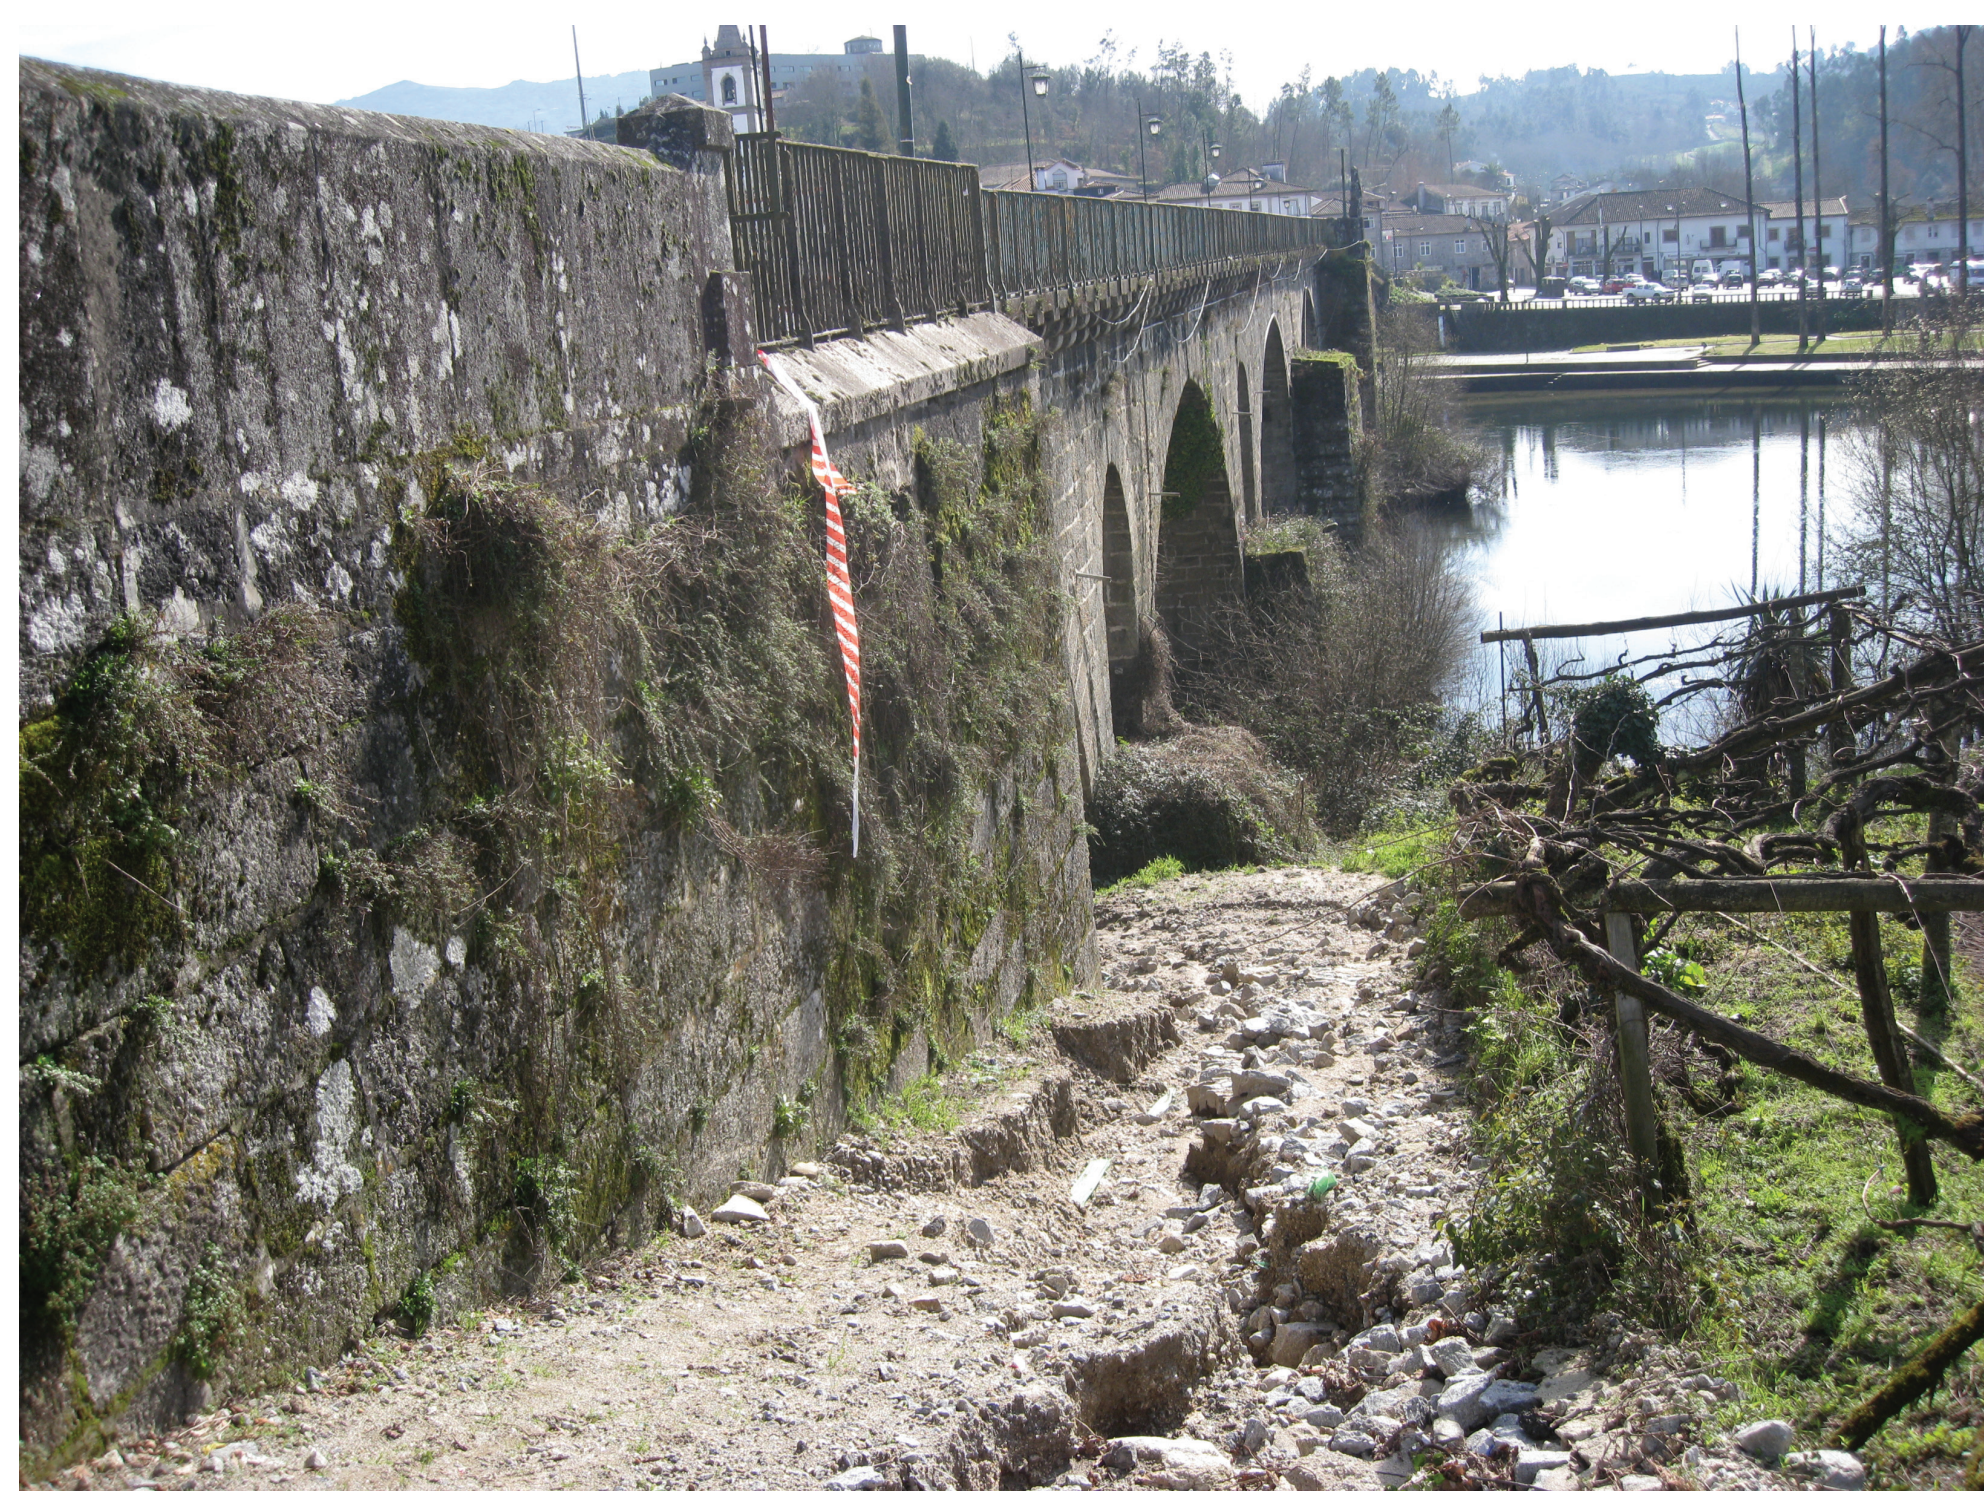
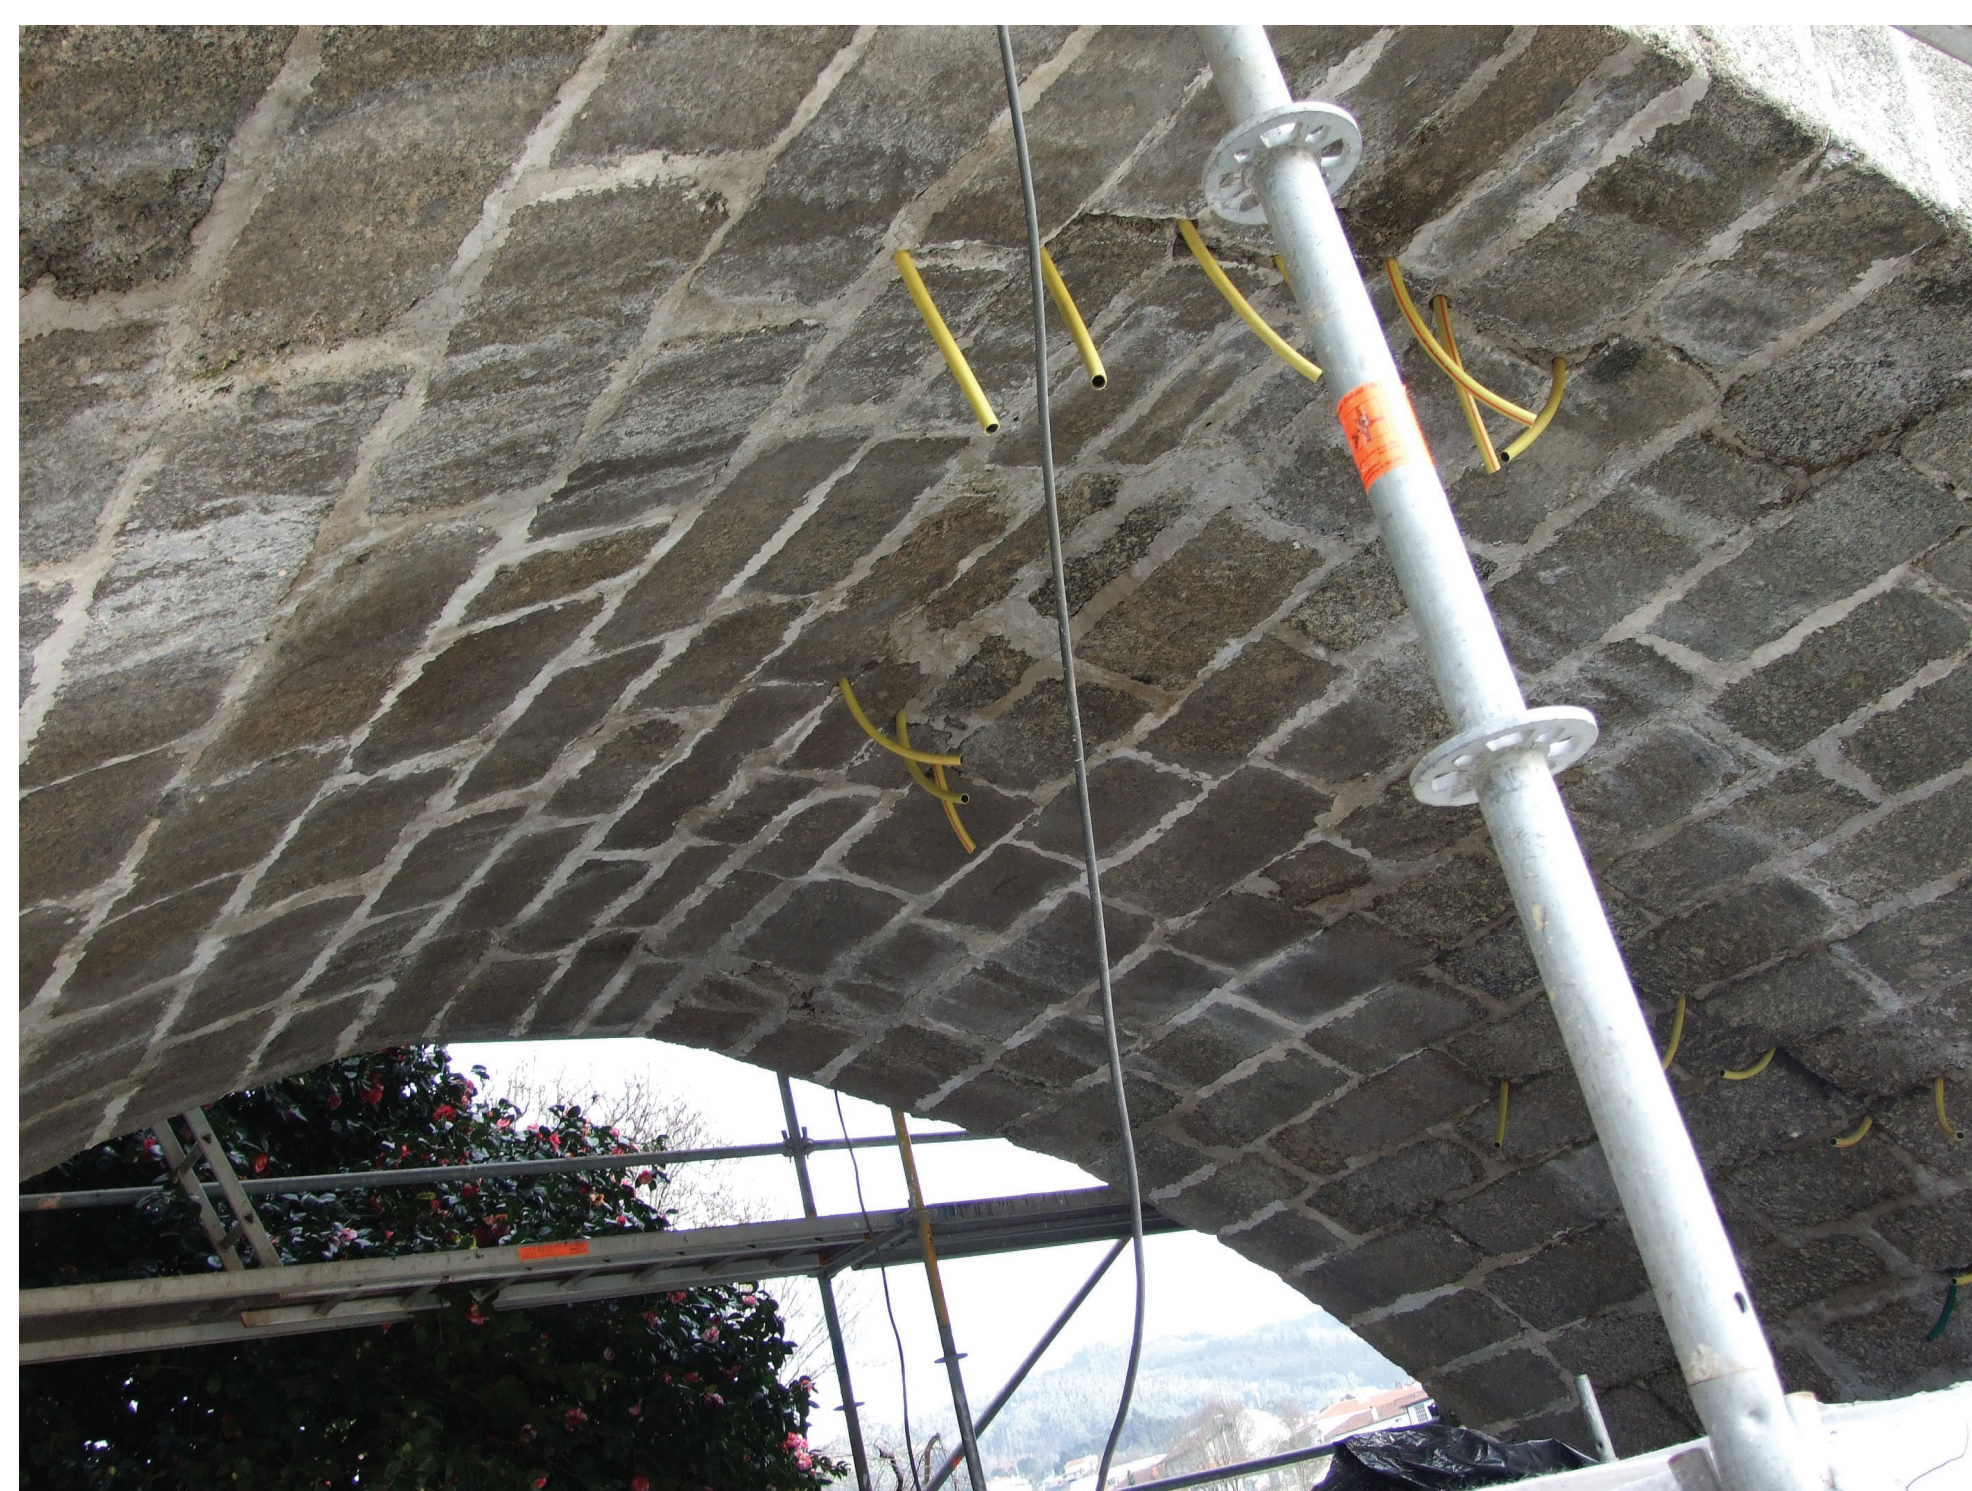
In 2007 several structural problems were diagnosed, namely:

- Sliding and changes in the shape of the breakwater adjacent to the central pier
- Fissures and vegetation growth on the piers
- Sliding of a pier base, downstream
- Fissures visible on the arches

In 2009 a new inspection took place. This time, the lack of maintenance and repair had already caused damage. The breakwater adjacent to the central pier had collapsed, with several broken structural stones and filling mortar. The bridge stability, however, was not in danger. But an intervention was necessary before the start of the rain season and it did take place in 2010.

One of the pier bases, on the downstream side of the bridge, was by then already separated from the corresponding pier. The access way to the down section of the bridge, on the northern side, had almost no pavement and exhibited large fissures on the support sediments, challenging access to the bridge and risking the collapse of the foundation of the first arch, had the intervention not promptly taken place. The bridge support wall was also damaged and it could affect its foundations and the bridge structural safety.

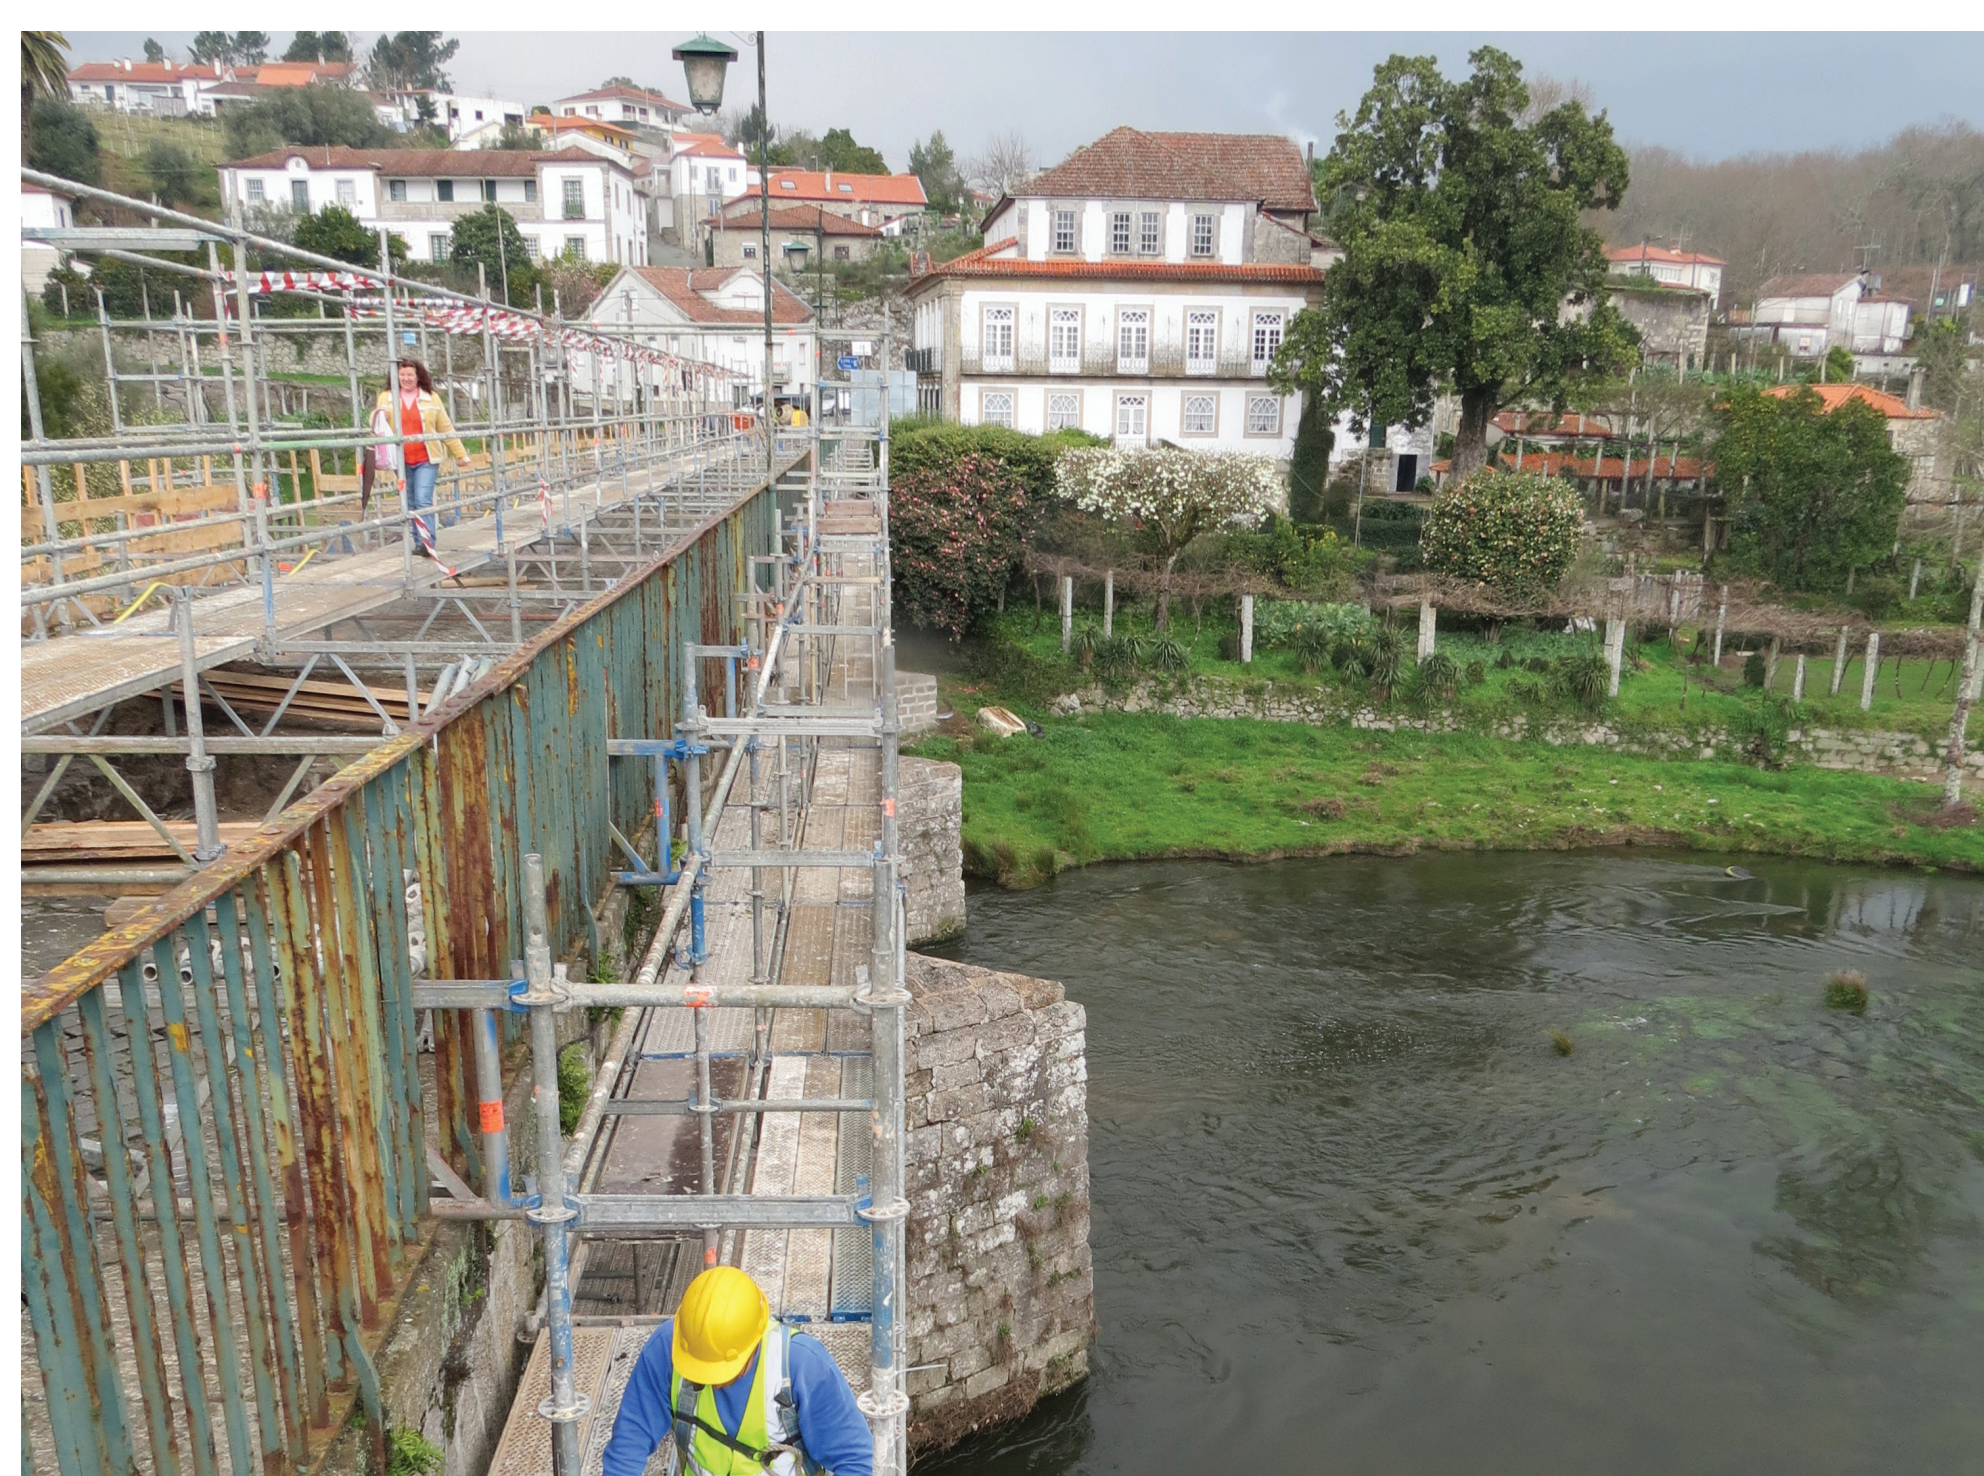
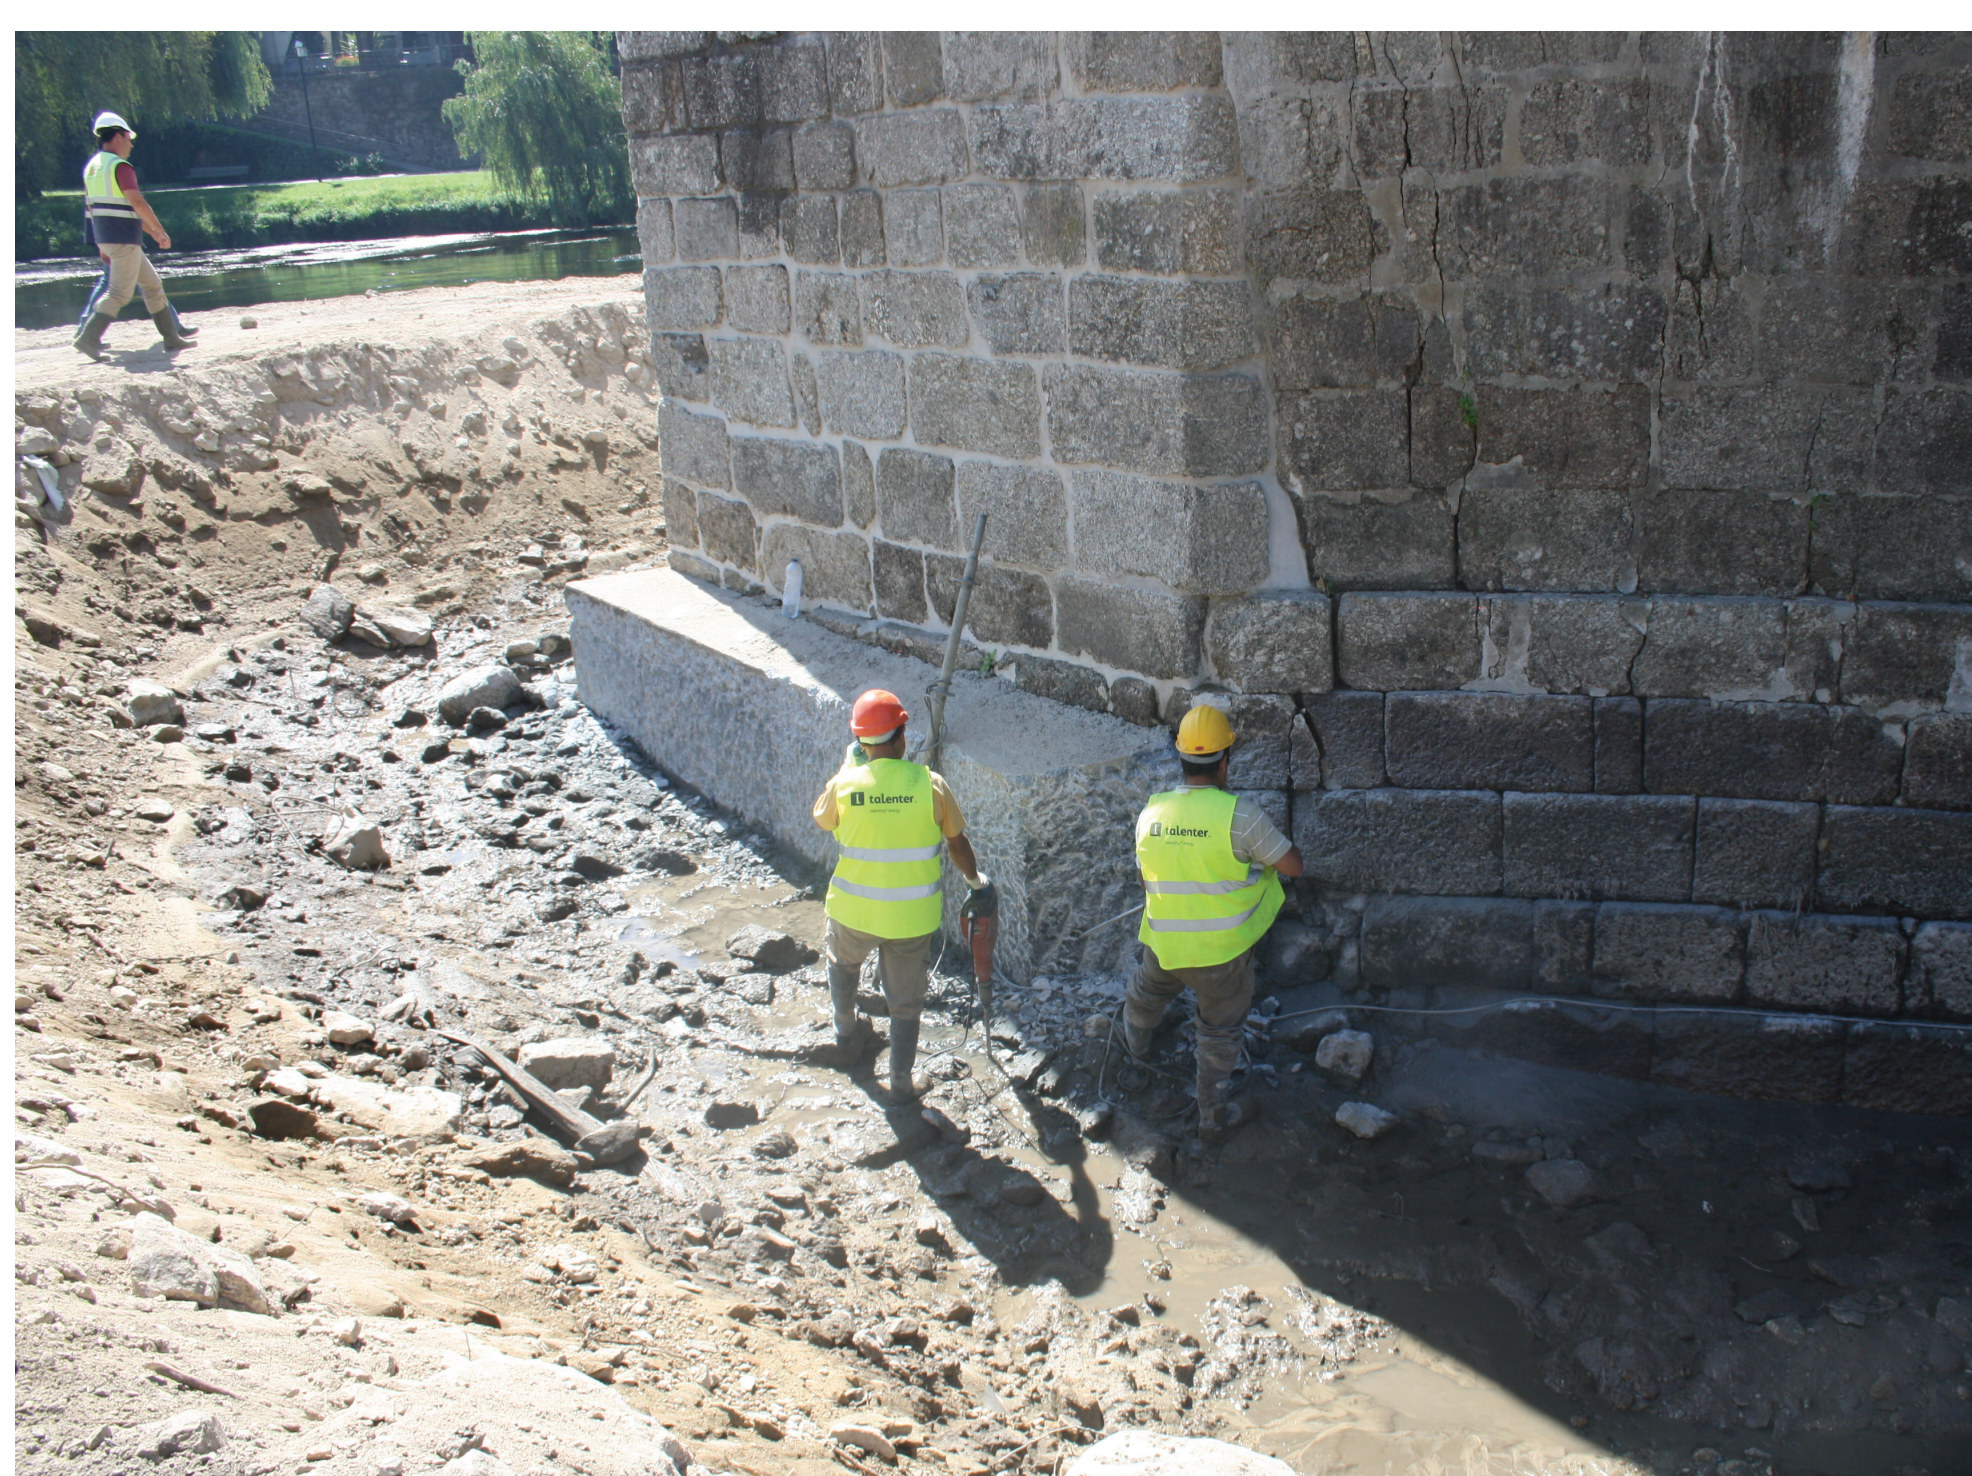
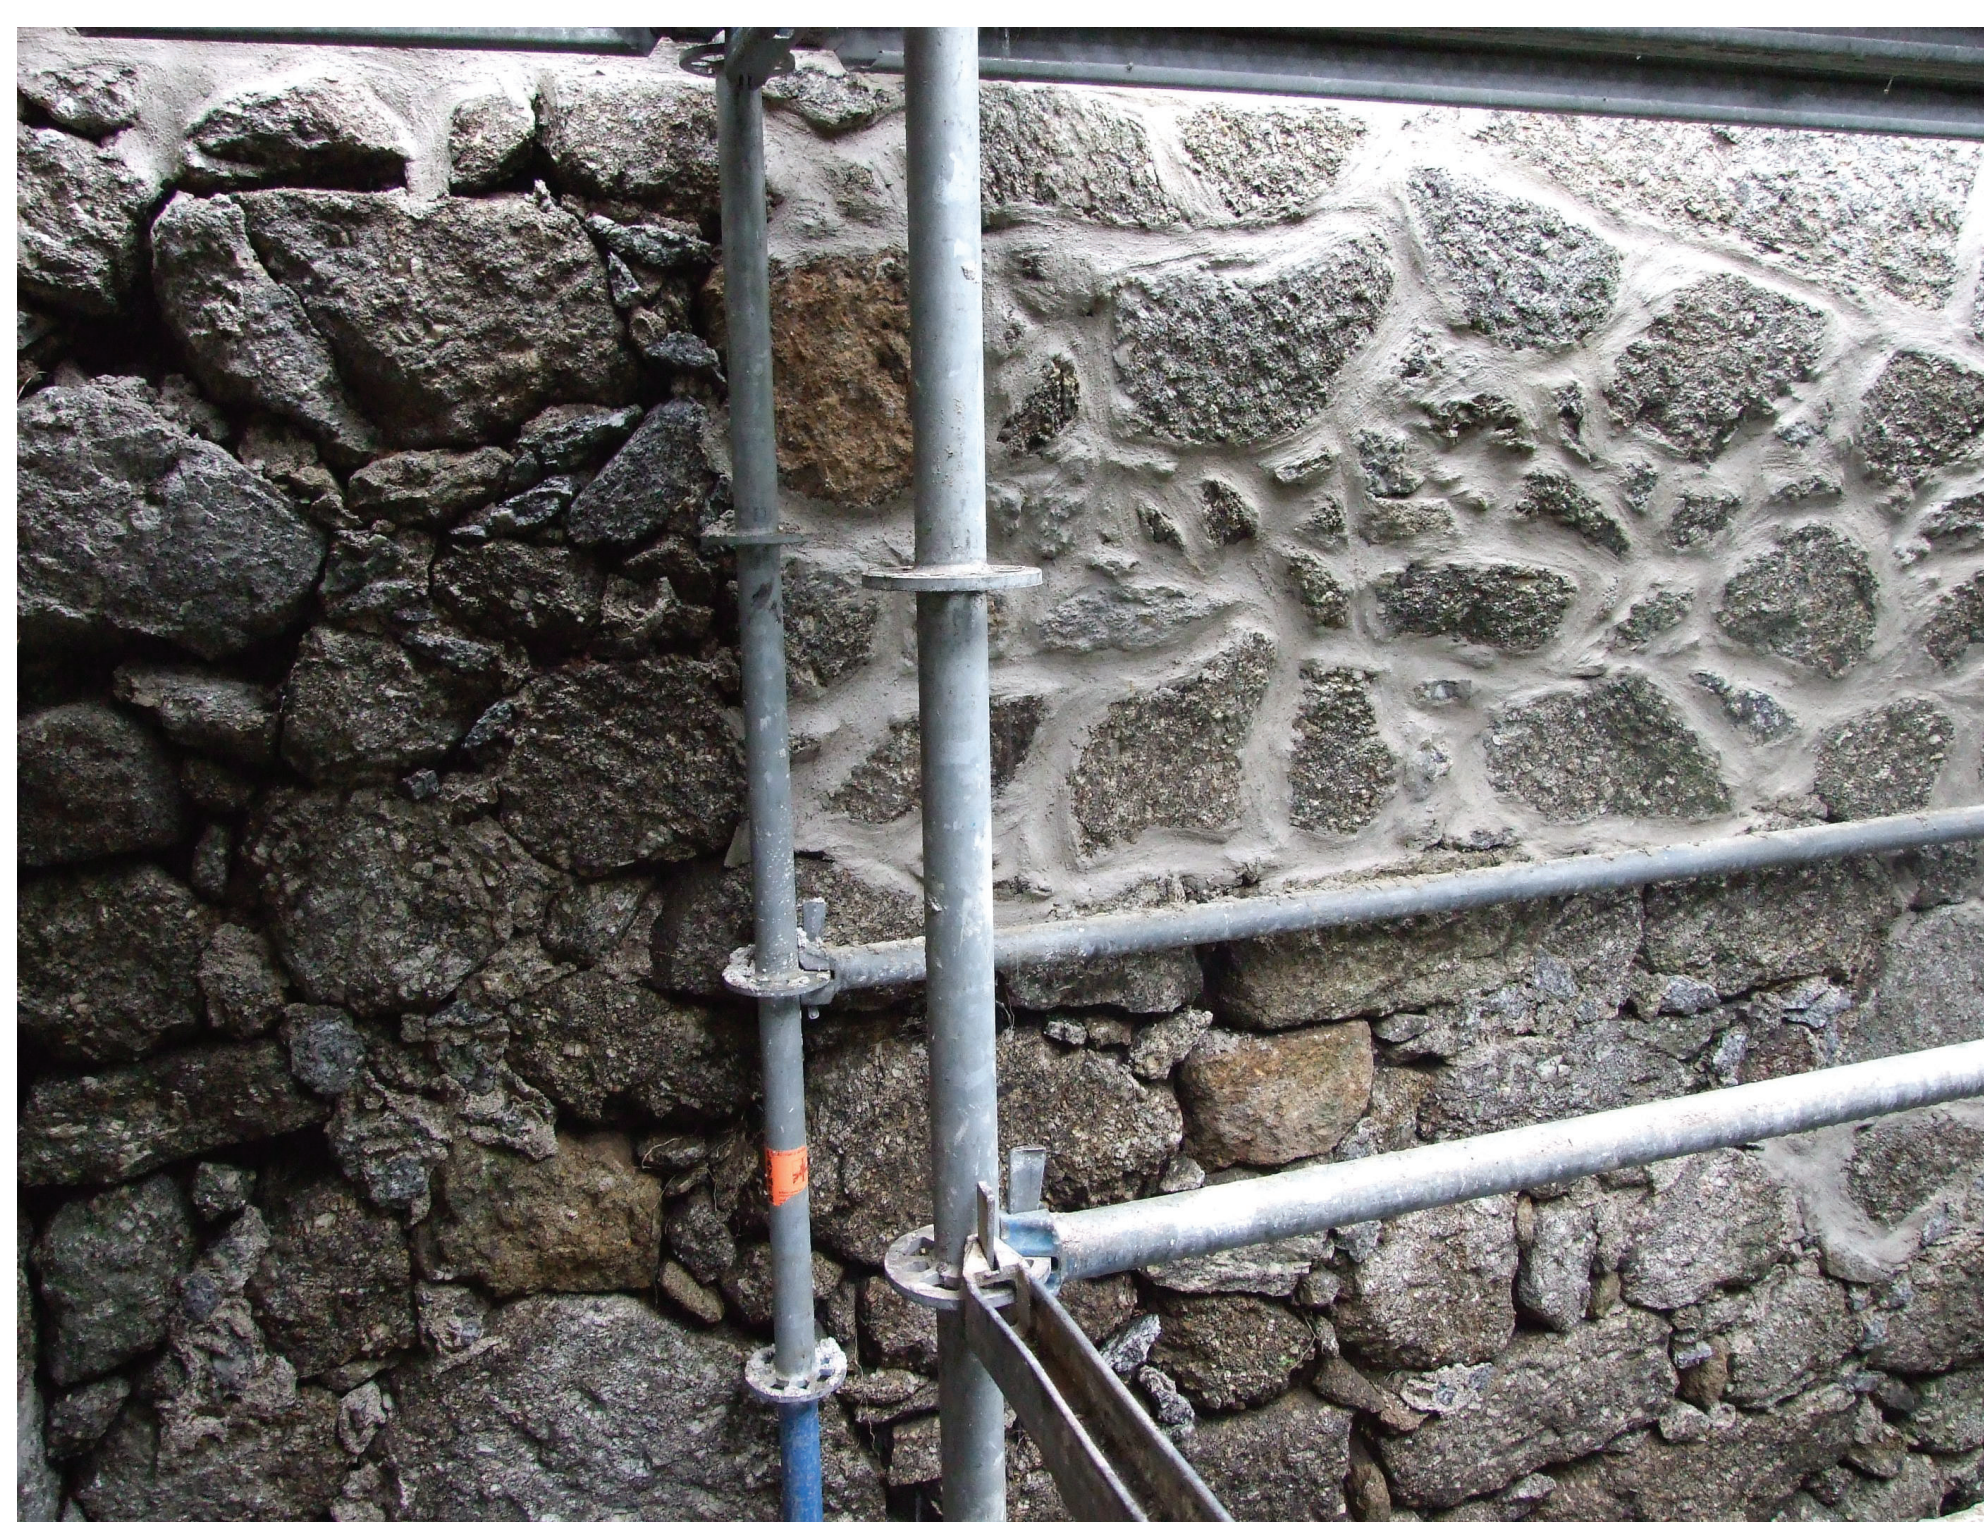
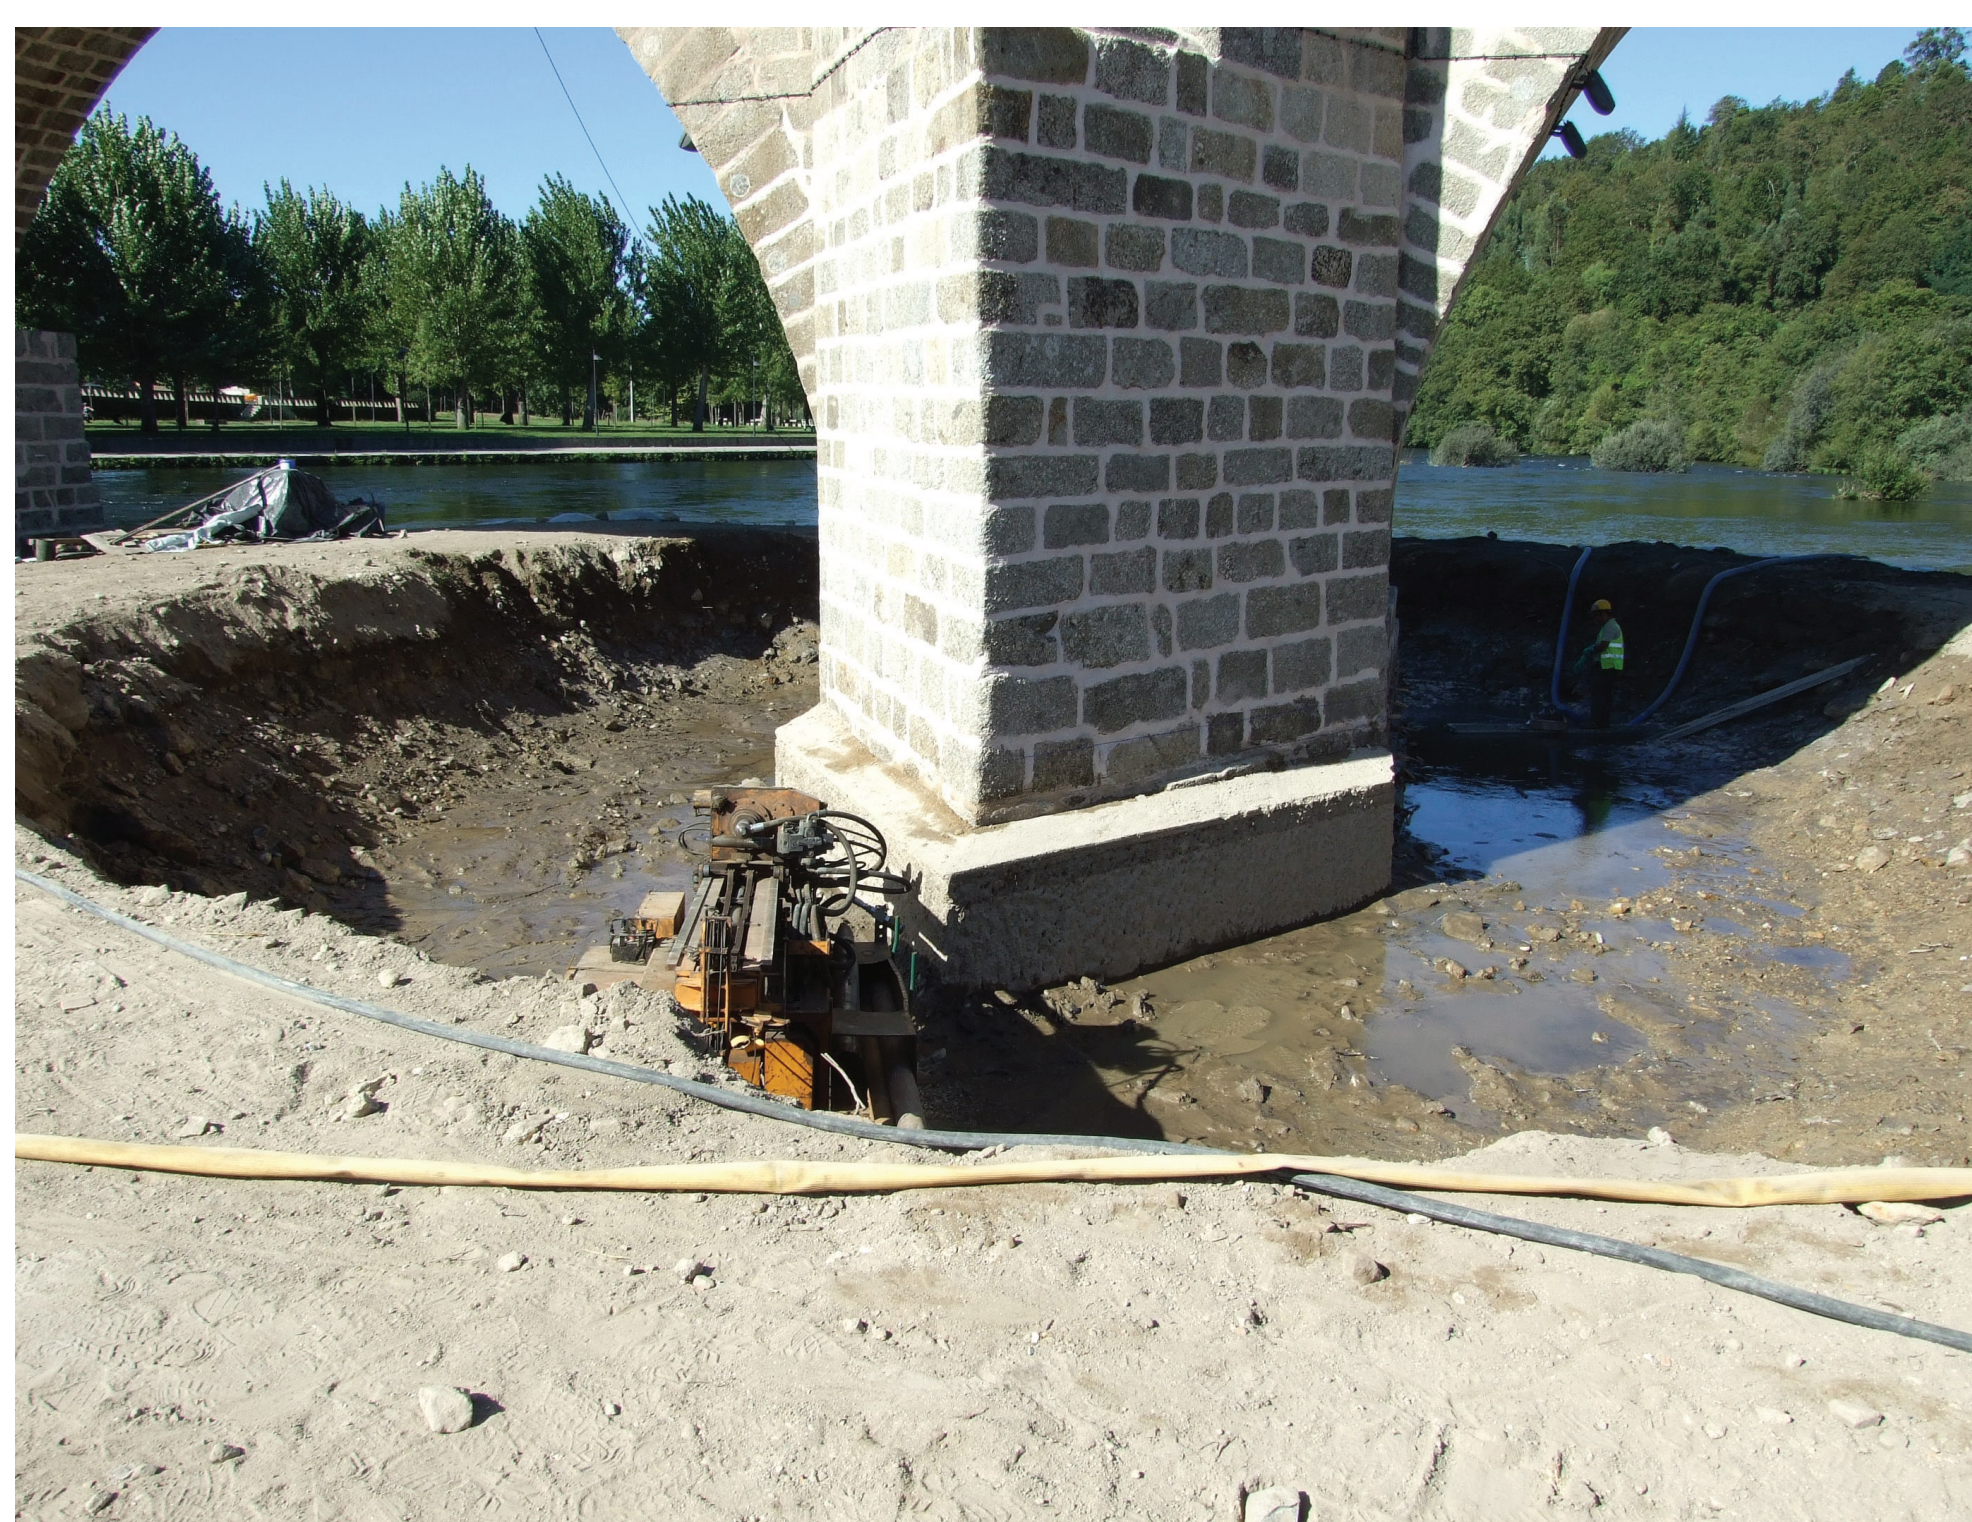
3. In 2010, an emergency intervention took place for the breakwater repair. It was disassembled and reconstructed, using the original stone elements and the same construction techniques as before, with hydraulic lime based mortars and pre-measured pozzolan.

4. Next, in 2013, a general bridge rehabilitation intervention took place, involving some reinforcement and improvement measures, such as a water proof bridge deck and the application of beams on the central arches.
